# NORTHERN KILIMANJARO ECOLOGICAL RESEARCH STATION

**A Preliminary Assessment of**  
the viability of siting an  
**Ecological Research Station**  
in the  
**Northern Kilimanjaro Area**

## **Report Following Preliminary Assessment**

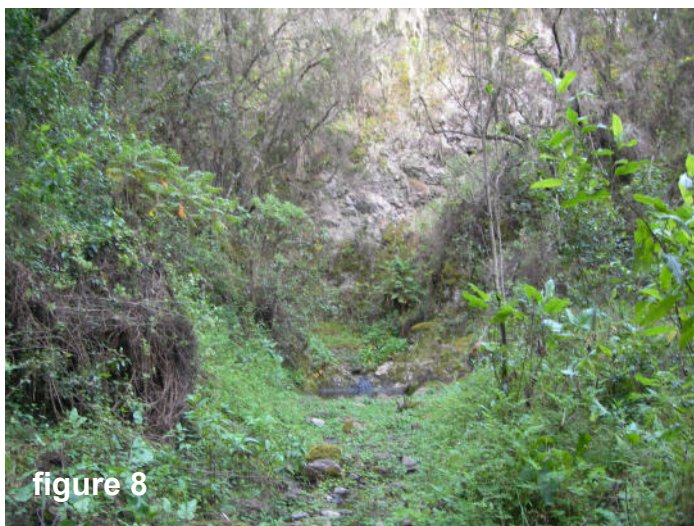
figure 8

**An Eastern Tributary of Olmatio River at 2753m**

*flow rate est. 4 litres per minute*

*note: following recent rainfall*

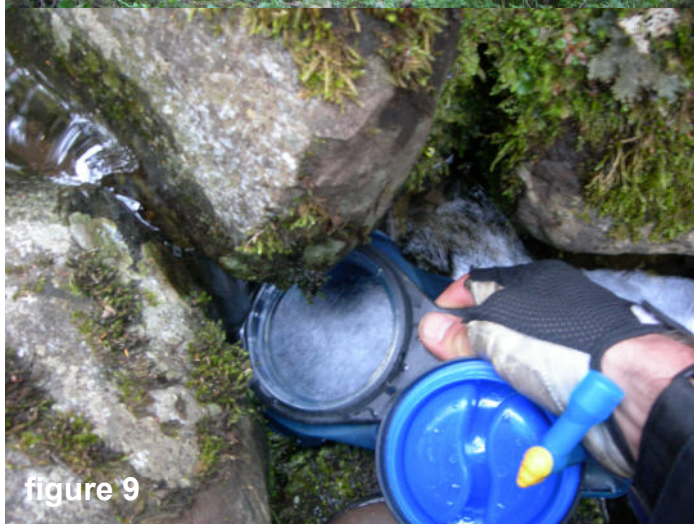
figure 9

**Eastern Tributary (see fig. 8) of Olmatio River at 2748m**

*estimating the flow rate at 4 l / min*

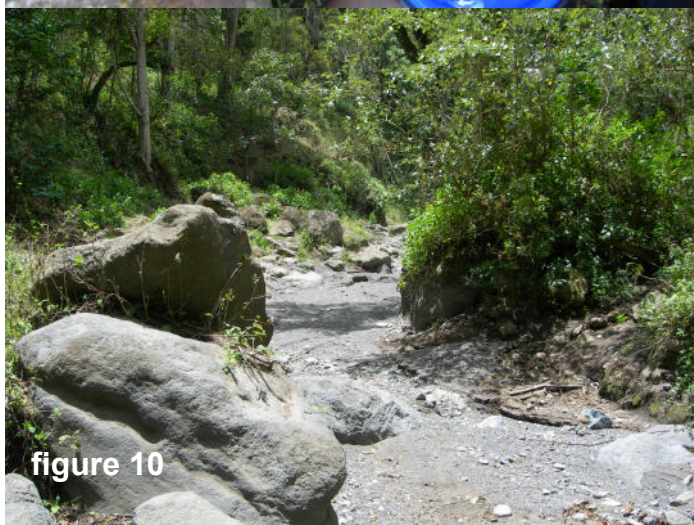
figure 10

**The Kamwanga River at 2020m**

*completely dry*

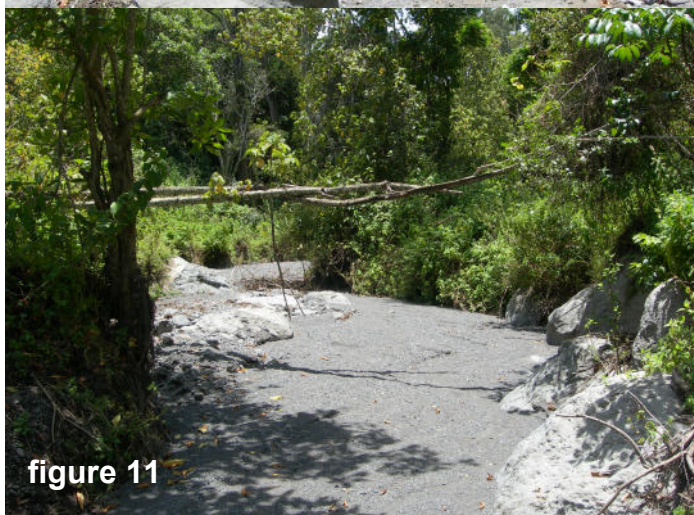
figure 11

**The Msanga River at 2058m**

*completely dry*

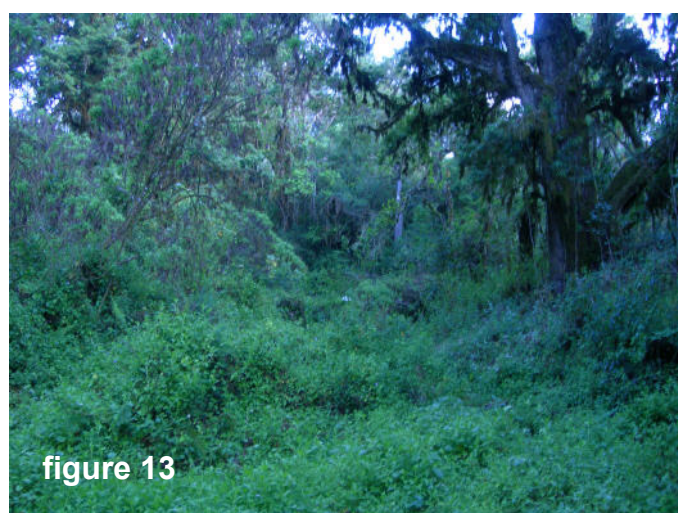
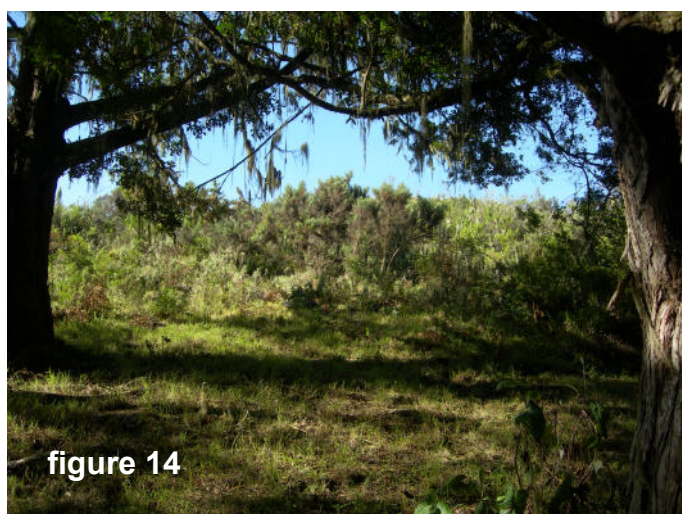
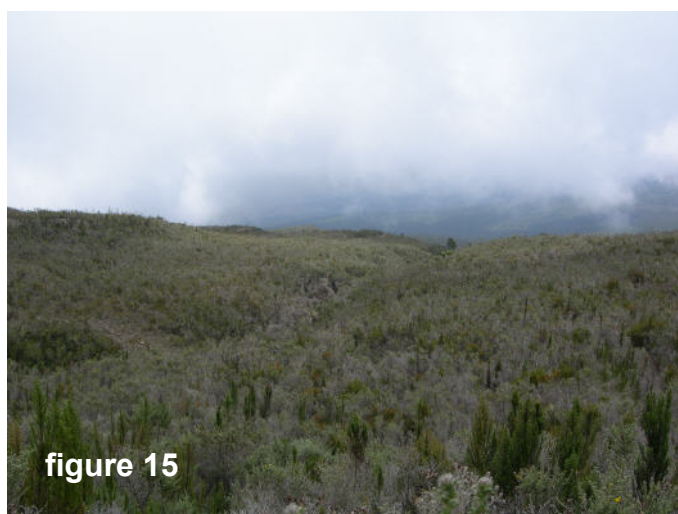
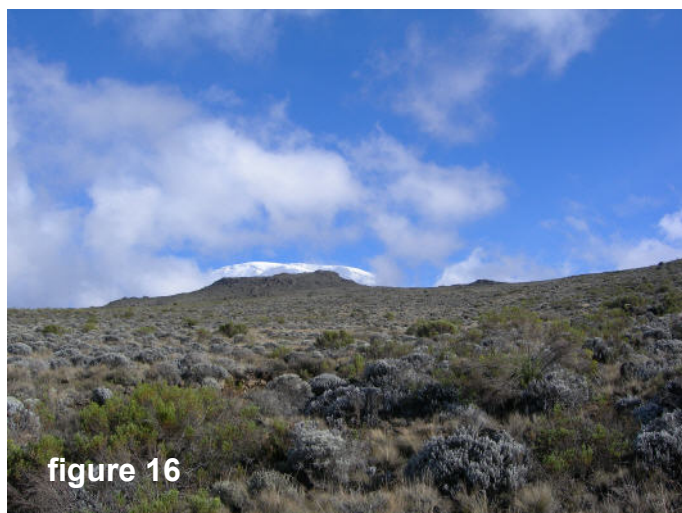
- 10.9km of lower montane Agauria-Ocotea / montane Cassipourea indigenous forest from 1771m to 2570m, (figure 12), becoming interspersed with :
- sections of subalpine Juniperus forest from 2500m to 2570m, (figure 13)
- 4.3km of subalpine Hagenia forest to an altitude of 2825m, (figure 14), where it emerges onto:
- 4.0km of Erica trimera bush from 2825m to 3415m, (figure 15)
- 4.7km of Helichrysum newii vegetation from 3415m to 4170m, (figure 16)
- 6.7km of bare rock and scree from 4170m to 5495m, (figure 17)
- 4.2 km of glacier and scree from 5495m to Furtwangler Glacier photo-surveillance point at high point on crater rim, 5889m, (figure B2, Appendix B).

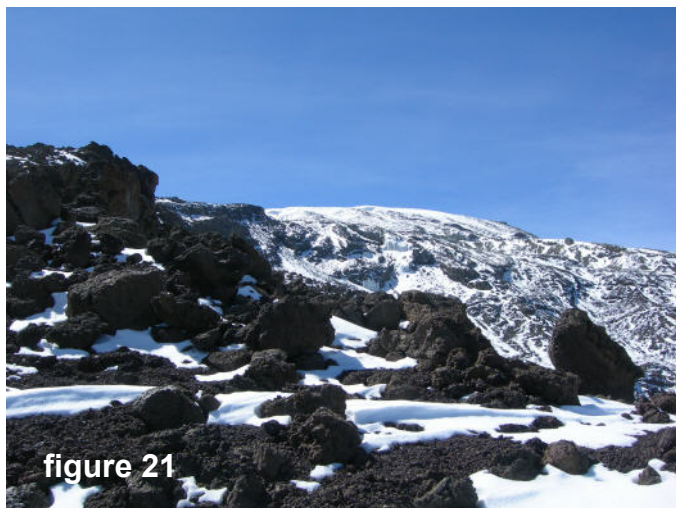
**figure 21**

**final ridge to Credner Glacier**  
*looking south east towards Uhuru (not visible).  
 The route runs diagonally upward, left of picture.*

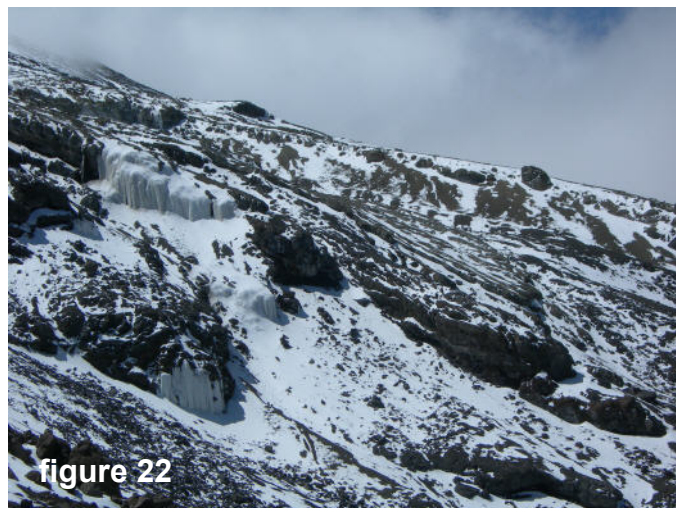
**figure 22**

**remains of the Credner Glacier at 5200m**  
*looking upward from 5140m. Marked recession has  
 occurred in recent years with very little now remaining*

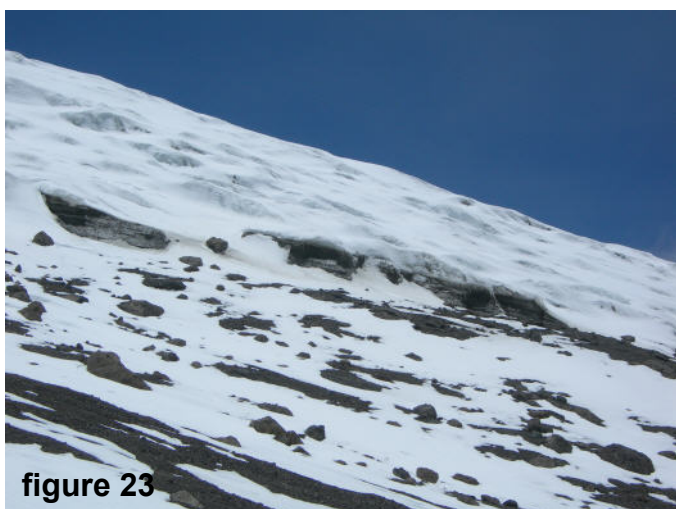
**figure 23**

**remains of the Credner Glacier at 5450m**  
*survey is proposed from this point to glacier's snout, be-  
 low, where altitude and GPS co-ordinates should be  
 regularly recorded throughout year*

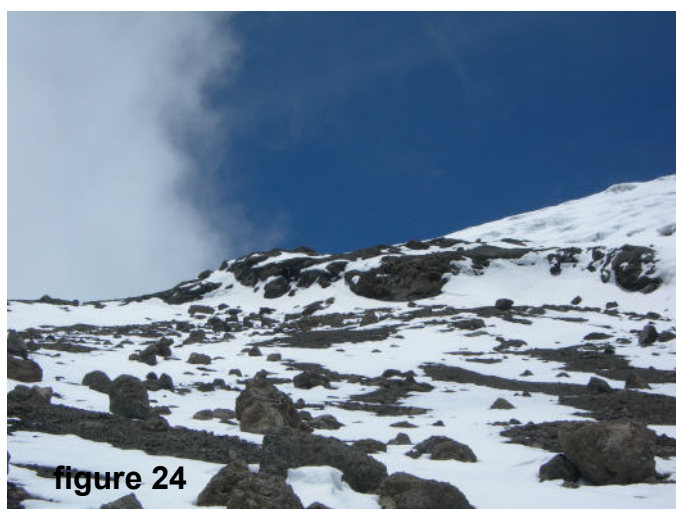
**figure 24**

**point where north west spur meets Credner Glacier**  
*just beyond rock outcrop route turns right to attain  
 Credner Glacier. From which point crampons and  
 ice-axe are required*

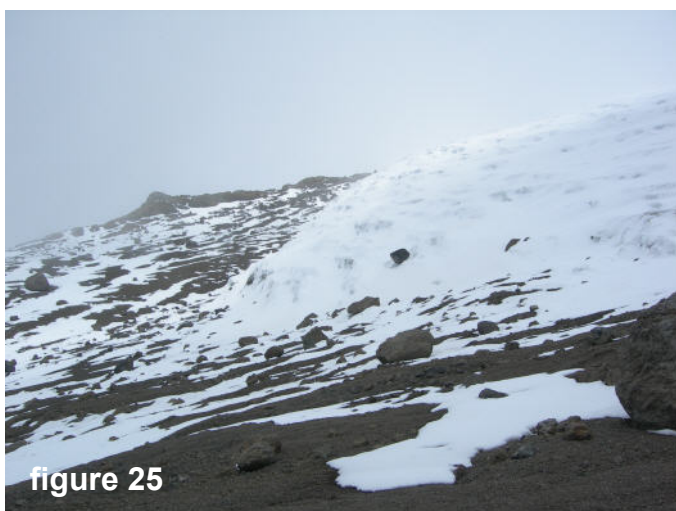
**figure 25**

**northern tip of Credner Glacier**  
*this edge to be marked with surveying rods and GPS co-  
 ordinates logged with regular patrols surveying this site  
 in order to record the recession over time*

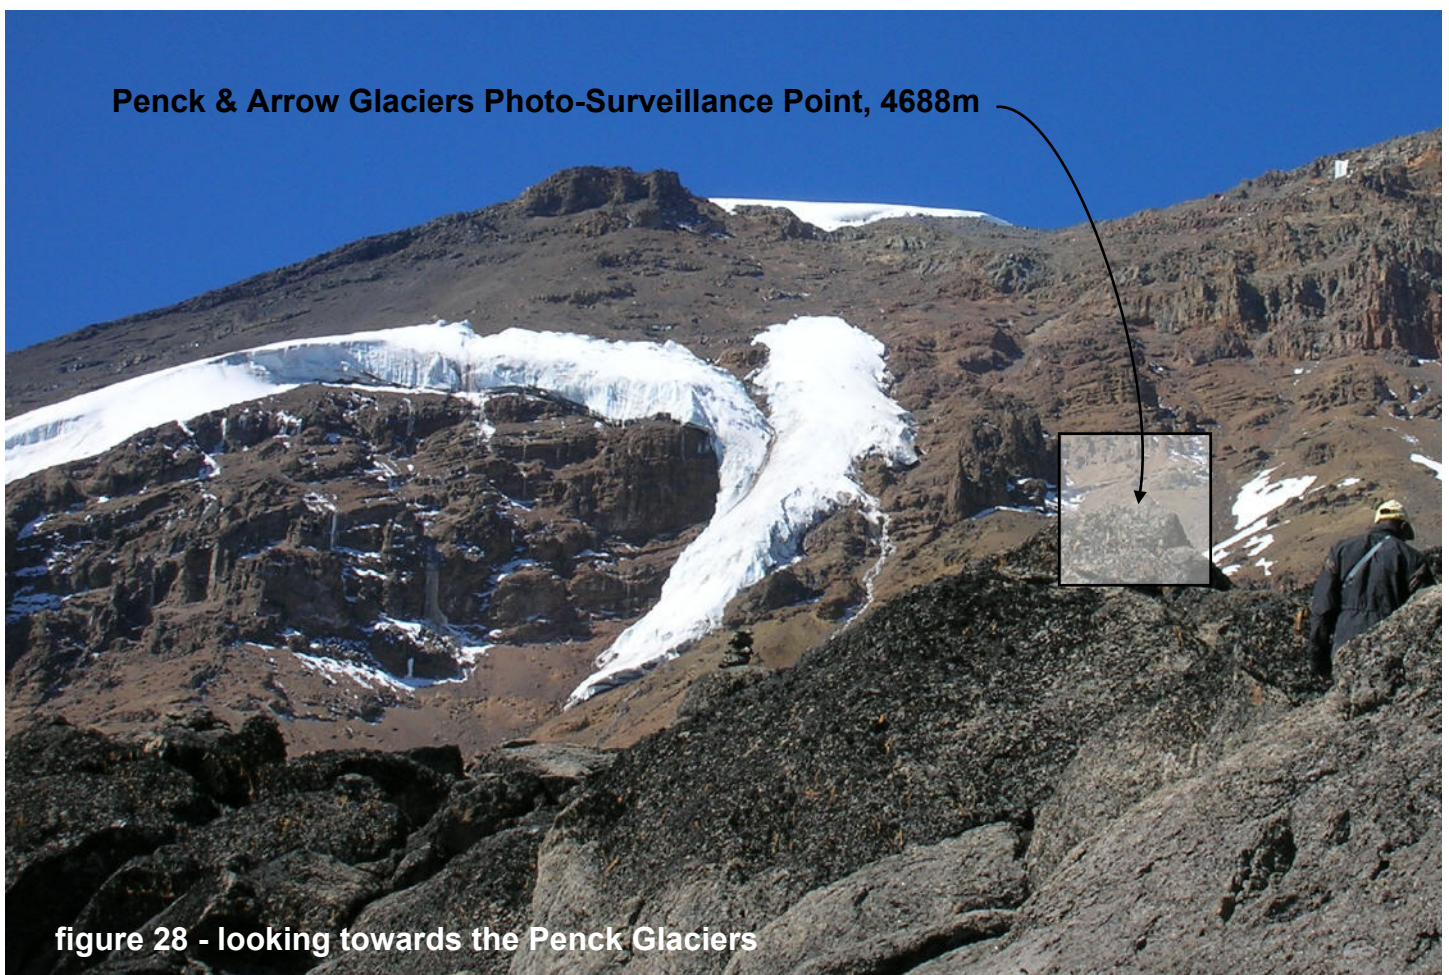
From Camp 2, 4174m, surveillance route proposed to Penck and Arrow Glaciers Photo-Surveillance Point at 4688m, see figures C1 and figure 28 (below). Telescopic photographic equipment to be used at this point with images catalogued for future comparison.

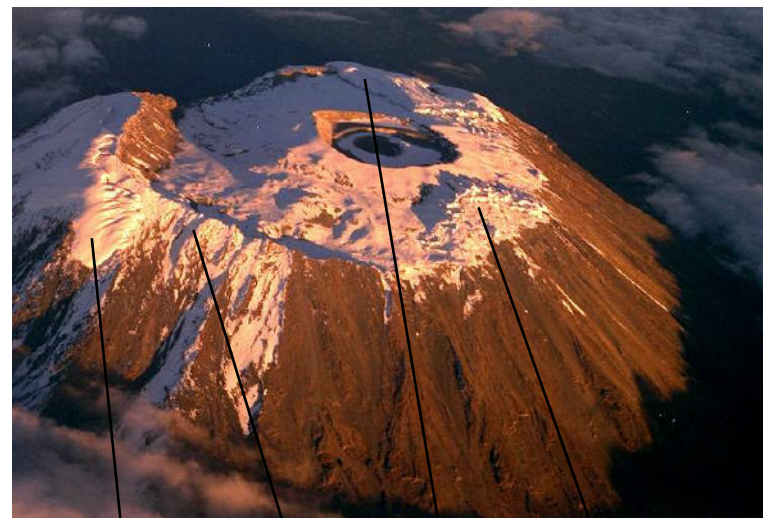
Rebmann Ratzel Northern and Eastern Icefields

*(Est 2000, above, & 2003, below.: Aerial Views of Kibo from East)*

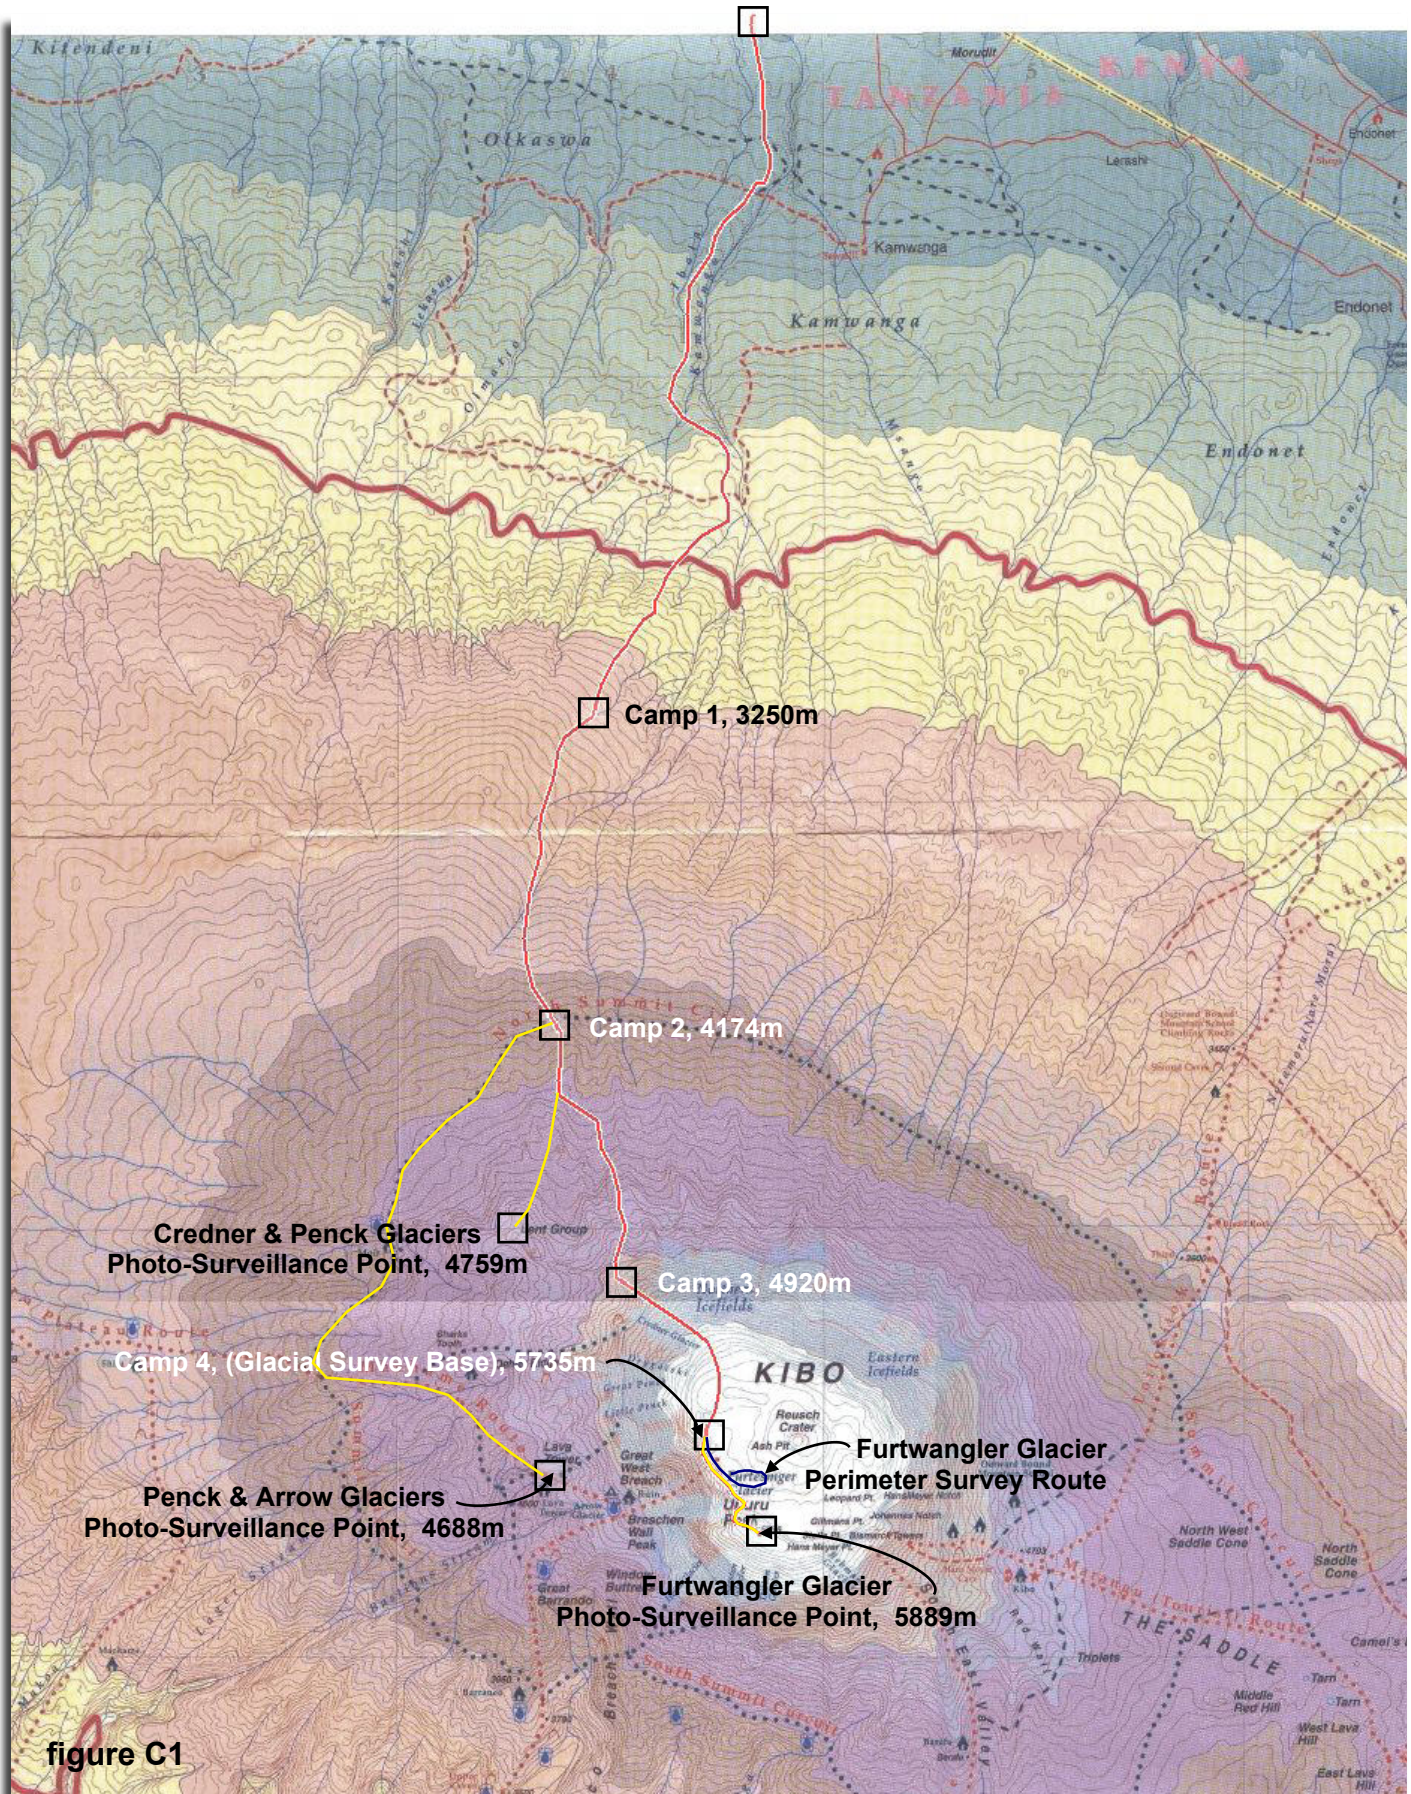
## Appendix C - Kilimanjaro Glacial Surveillance Route

### Route Start Point, Mlima Nyuki, 1771m

See figure C1, Appendix C, showing the northerly course beginning at Mlima Nyuki. From the village the 34.8km route proceeds through:

From Camp 2, 4174m, surveillance route proposed to Credner & Penck Glaciers Photo-Surveillance Point at 4759m, see figure C1. Telescopic photographic equipment to be used at this point with images catalogued for future comparison.
